Royal Commission on the
Ocean Ranger Marine Disaster

**Report One: The Loss of the Semisubmersible
Drill Rig *Ocean Ranger* and its Crew**

The Royal Commission on the *Ocean Ranger*
Marine Disaster was jointly established and
funded by the Governments of
Canada and Newfoundland

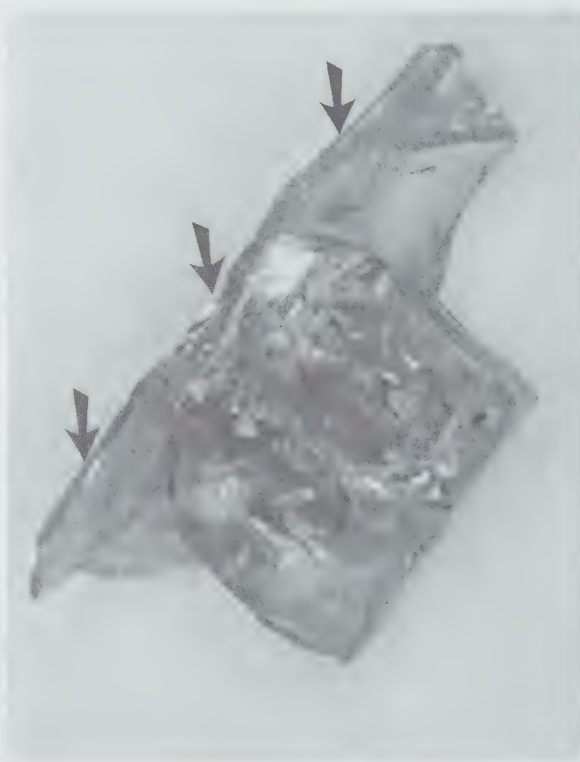
2.3 Detailed examination of porthole No. 1 revealed that the glass remnants were sloped towards the inboard side of the porthole. Using a level and a dial indicator, it was possible to measure the slope of the glass on the outboard surface. The calculated slope angle of the glass surface was 2.3 degrees. The direction of slope on the glass indicates an inward force on the glass caused failure. The locking ring was removed from the porthole and the glass was removed, Photo 11. The rubber glass seal was found intact and in place in its groove. One distinctive characteristic of the glass fragments was the pattern of cracking, Photo 12. In all cases, the outboard surface of the glass had formed what could be described as a "shear lip". This cracking pattern is typical of a bending overload failure with the direction of force acting from the outboard to the inboard side of the glass.

PHOTO 12 Glass fragment from porthole No. 1 displays a distinctive shear lip on the outboard side of the glass (arrows).

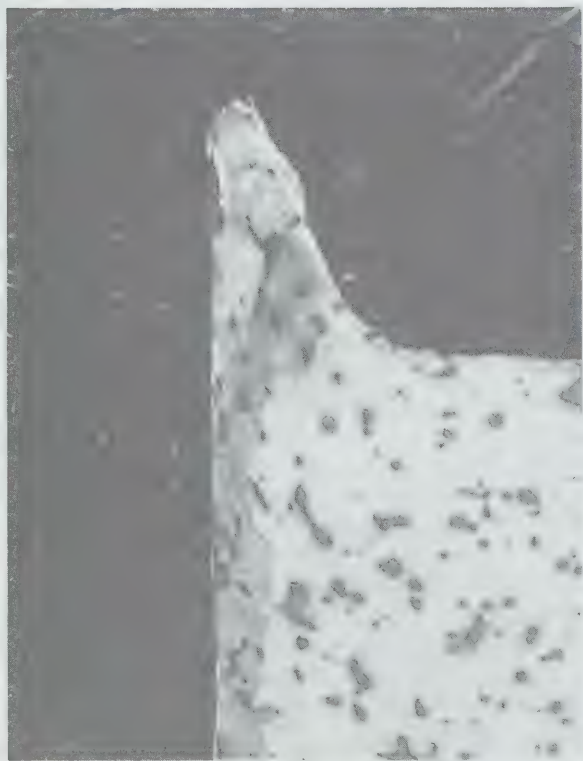
2.4 Detailed examination of porthole No. 4 revealed a protruding "lip" of metal on the locking ring, Photo 13. This material lip was continuous around the circumference of the ring on the side adjacent to the glass. The ring was removed for closer examination. Photo 14 shows a polished and chemically etched cross section of the locking ring from porthole No. 4 illustrating the protruding lip. Examination of the material structure in the vicinity of the lip revealed a pattern of material flow indicating shear deformation of the ring at that point. A cross section of the ring was taken 180° opposite the section shown in Photo 14 for comparison. The magnitude of the shear deformation did not appear to differ by a measurable amount. This pattern of shear deformation and the continuous protruding lip around the full circumference of the ring, is an indication that glass failure occurred in an inboard direction

PHOTO 14 Cross section of locking ring shows protruding lip of material. Note the pattern of flow near the base of the lip indicating smearing deformation of the material.

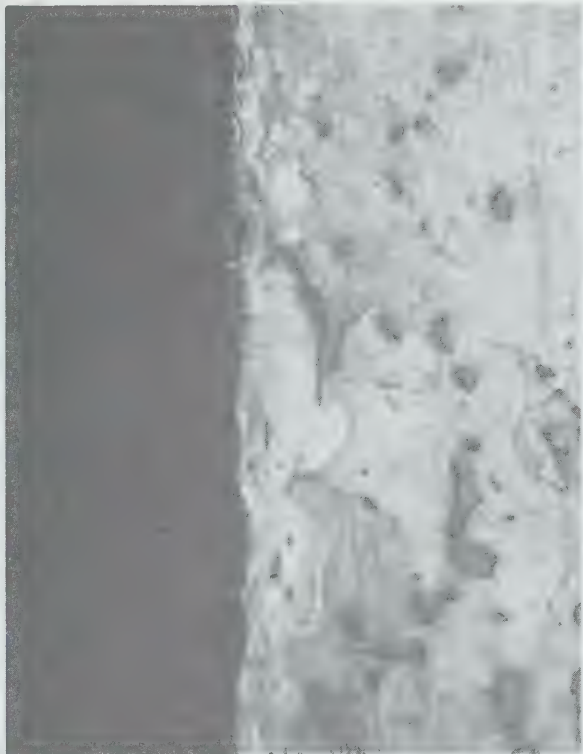
2.5 Metallurgical examination of the material microstructure of the locking rings revealed a narrow band of deformation slip lines (characterized by a crosshatch pattern) just below the ring surface which mates with the glass, Photo 15 and 16. The slip line pattern extended further below the surface in the ring from porthole No. 4 and was much more prevalent in the area of the protruding lip, Photo 17. Slip lines are formed as a result of deformation in the material and are characterized by a cross-hatch pattern.

PHOTO 15 Deformation slip lines (crosshatch pattern) adjacent to the glass mating surface of porthole No. 4 locking ring.

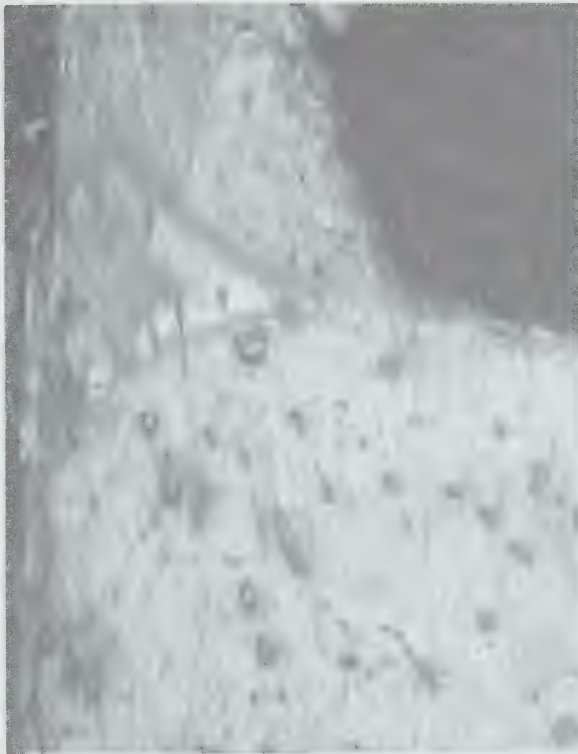
PHOTO 17 Porthole No. 4 locking ring cross section showing high concentration of deformation slip lines around the base of the protruding lip.

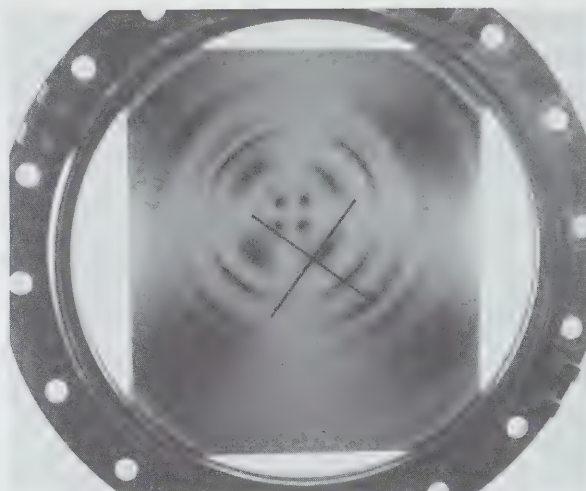
2.8 Microscopic examination of the rig's No. 2 porthole glass revealed extensive pitting on both sides of the glass, with a density of approximately one pit per ten square centimeters and an average pit size of half a millimeter. Pitting typically reduces the fracture strength of glass, especially tempered glass. In order to determine the effects of pitting, a new sheet of both Japanese and

PHOTO 3 Bifringe pattern of *Ocean Ranger* #2 porthole glass, showing strong stress gradients.

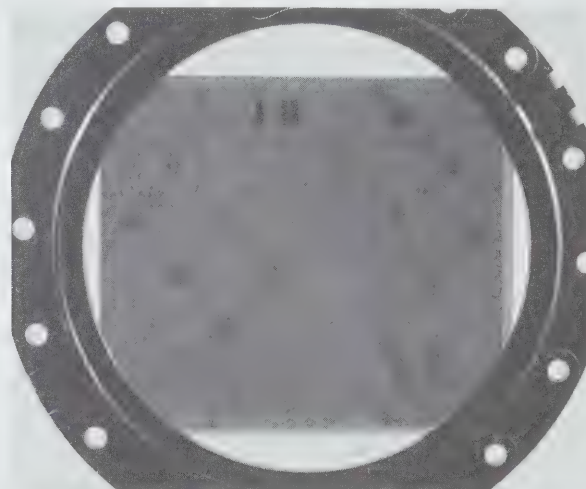
PHOTO 4 Bifringe pattern of Japanese glass (new) showing little stress gradients.

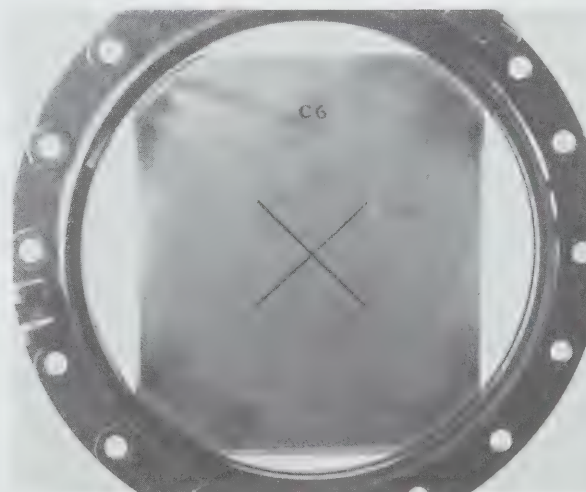
PHOTO 5 Bifringe pattern of Canadian glass (new) showing weak stress gradient patterns.

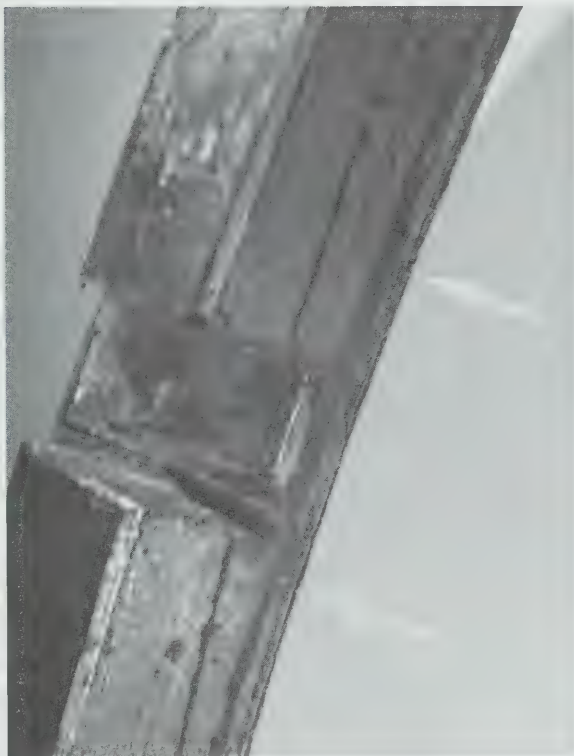
PHOTO 7 Glass retaining ring removed from porthole No. 2 shows protruding lip of deformed material (arrows).

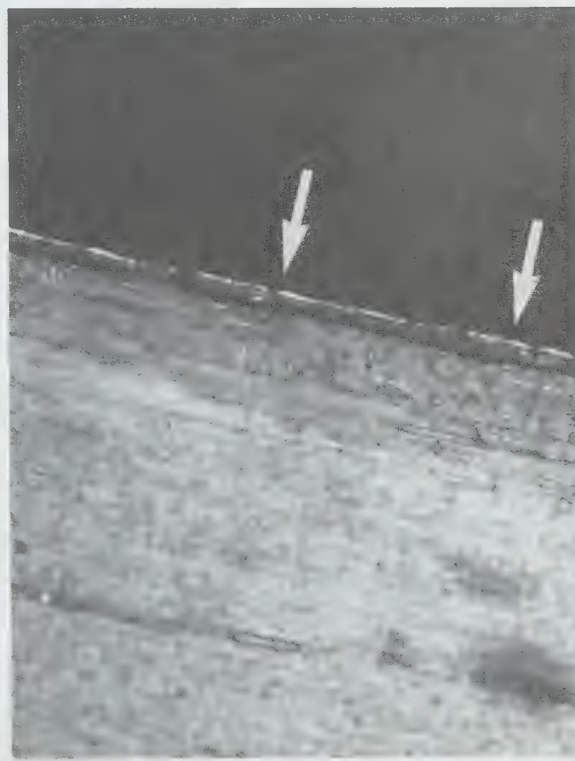
PHOTO 8 Close-up view of the material lip (arrows).

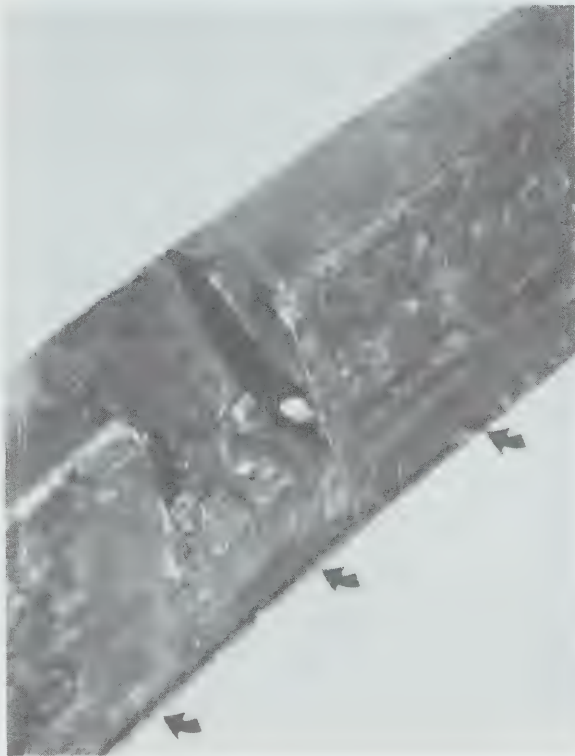
PHOTO 9 Glass retaining ring from porthole No. 4 shows similar protruding material lip (arrows).

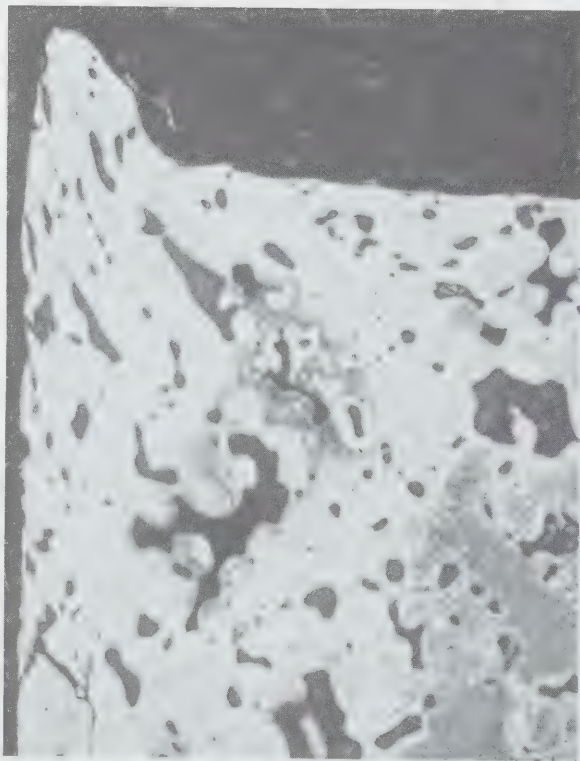
PHOTO 10 Cross section of retaining ring from porthole No. 2 shows distinct protruding lip. Note the pattern of flow at the lip indicating smearing deformation of the material.

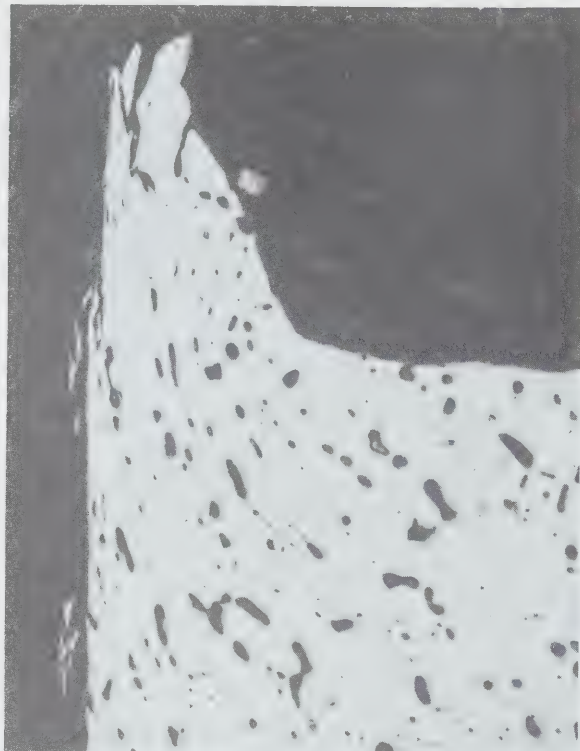
PHOTO 11 Cross section of retaining ring from porthole No. 4 shows similar protruding lip.

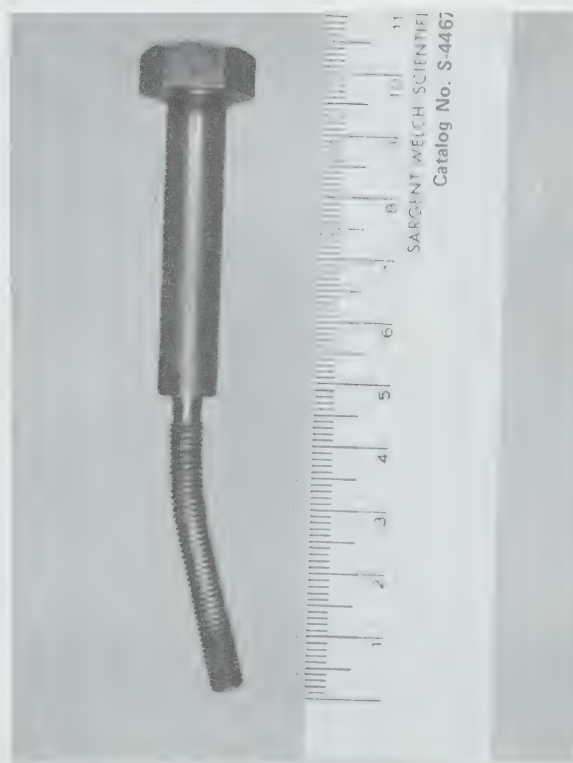
PHOTO 6 A bent actuator rod, as received.

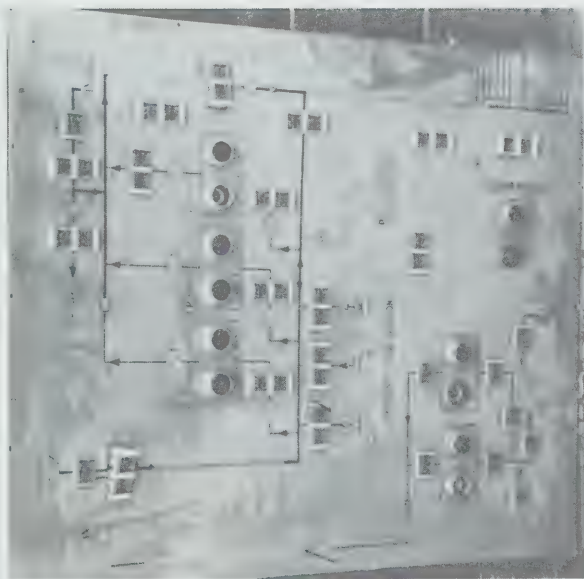
PHOTO 1 Pump room valve mimic panel (port side).

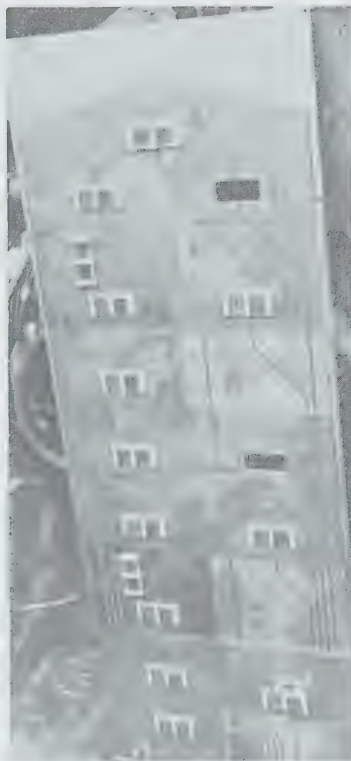
PHOTO 2 Tank valve mimic panel (port side).

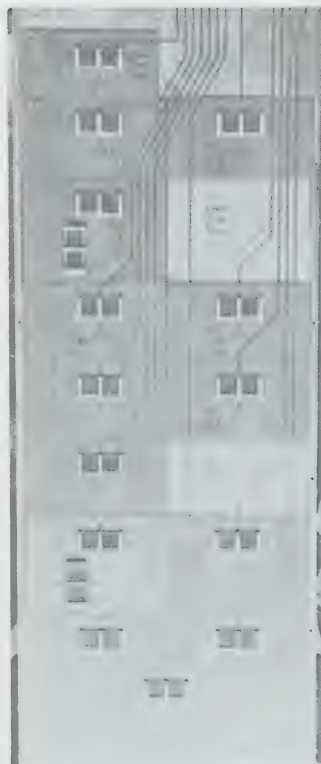
PHOTO 3 Tank valve mimic panel (starboard).

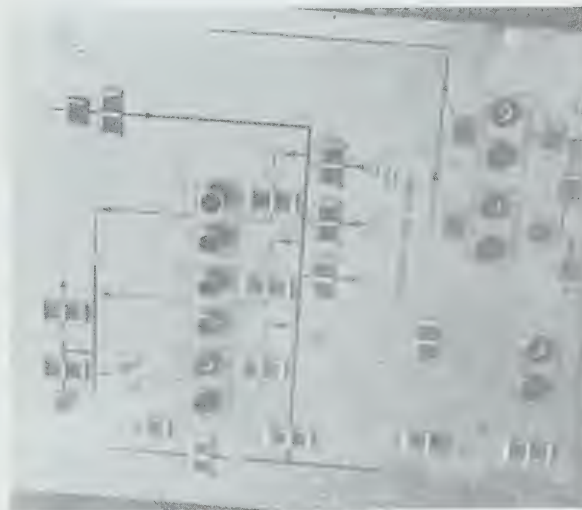
PHOTO 4 Pump room valve mimic panel (starboard).

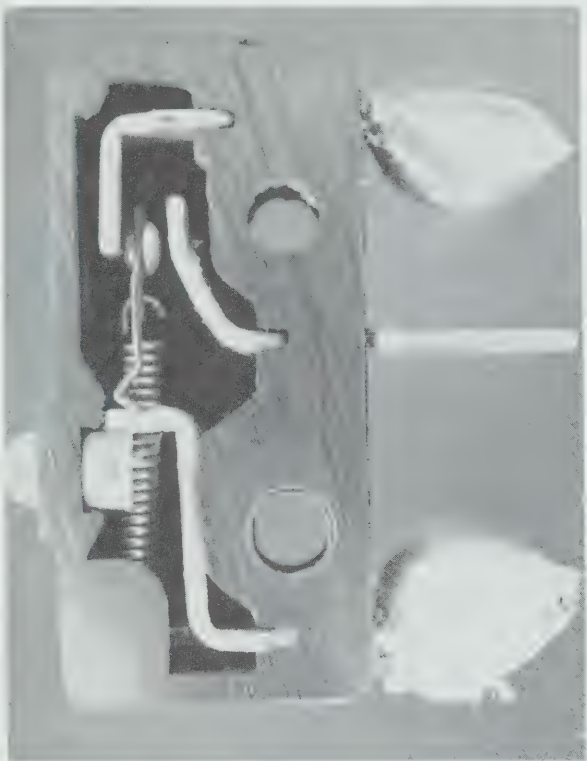
PHOTO 10 Micro switch Burgess V4T6 revealing interior mechanism and contacts.

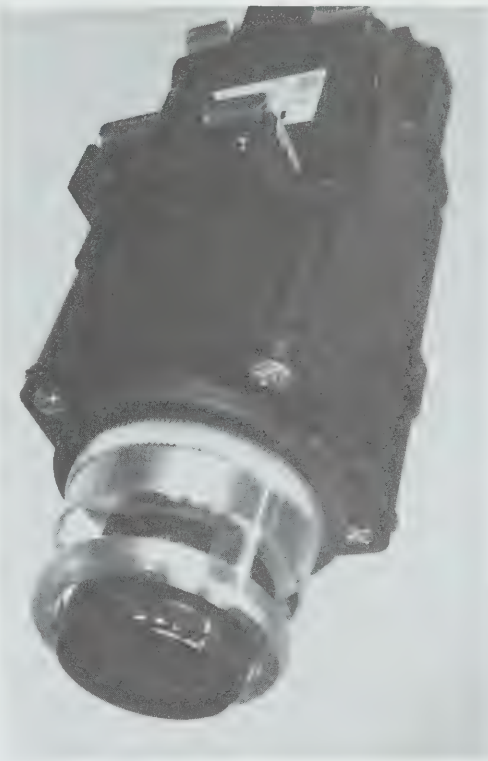
4.7 The shorting of switch "green" P-19 was most likely the site of leakage of the 115 volts into the 24 volt lamp circuit, causing the 68 light bulbs to blow.

PHOTO 12 Pump switch green.

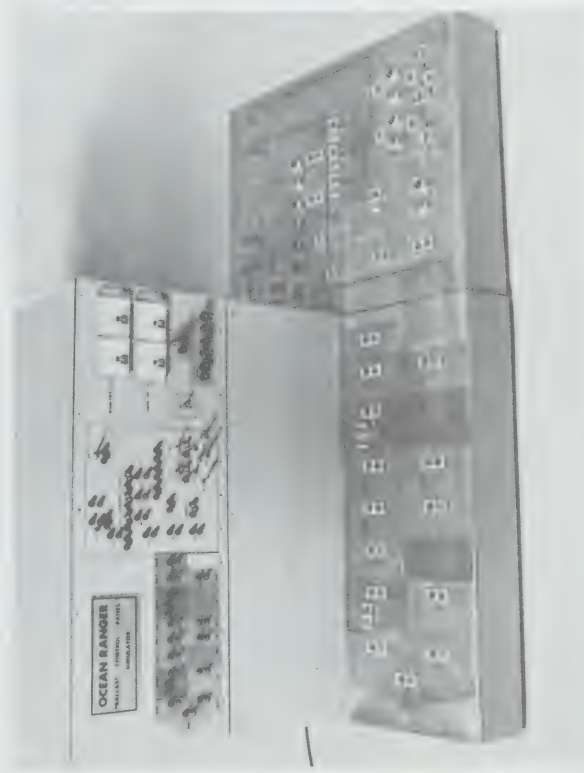
3.2 A simulation of the starboard side control panel shown in Photo 7 containing new General Electric type 327 bulbs was flooded with sea water to simulate observed damage to the control panel. The 24 volt circuit fuse blew shortly after and all the lights went out. After some time, lights began to flash

PHOTO 7 Simulation control panel of the Ocean Ranger.

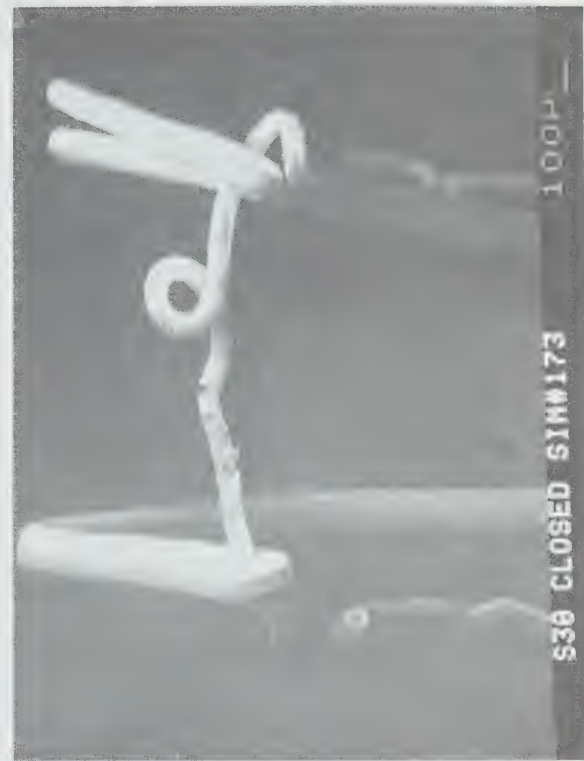
PHOTO 8 Filament from simulation panel flooded with water.

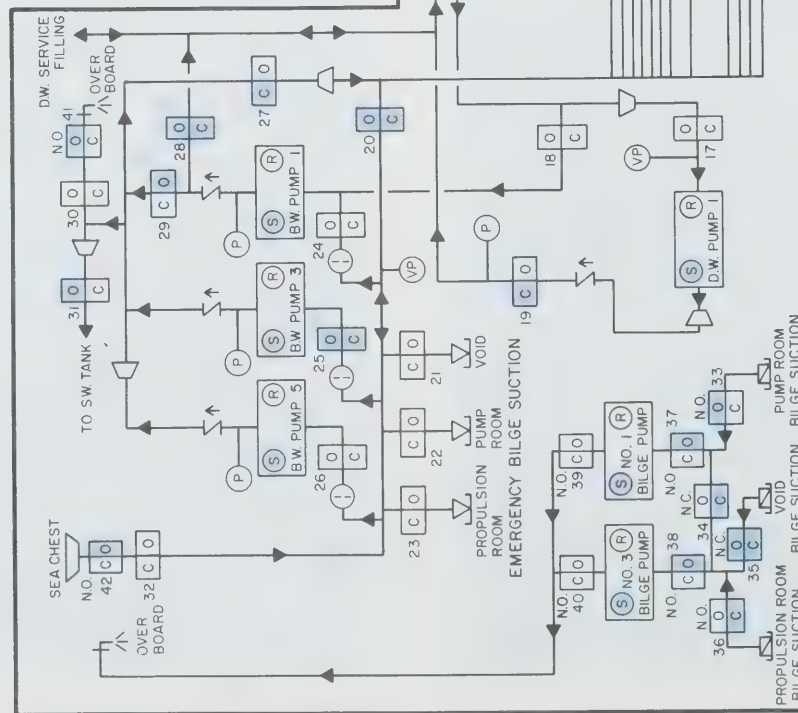
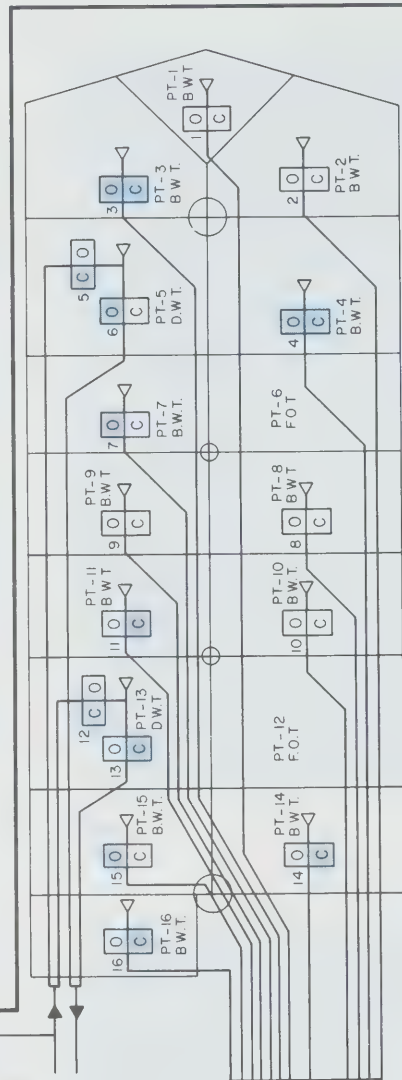
FIGURE 1 Port Mimic Panel.

BRITTLE FRACTURE ☐ BULB DAMAGED DUE TO OVERVOLTAGE

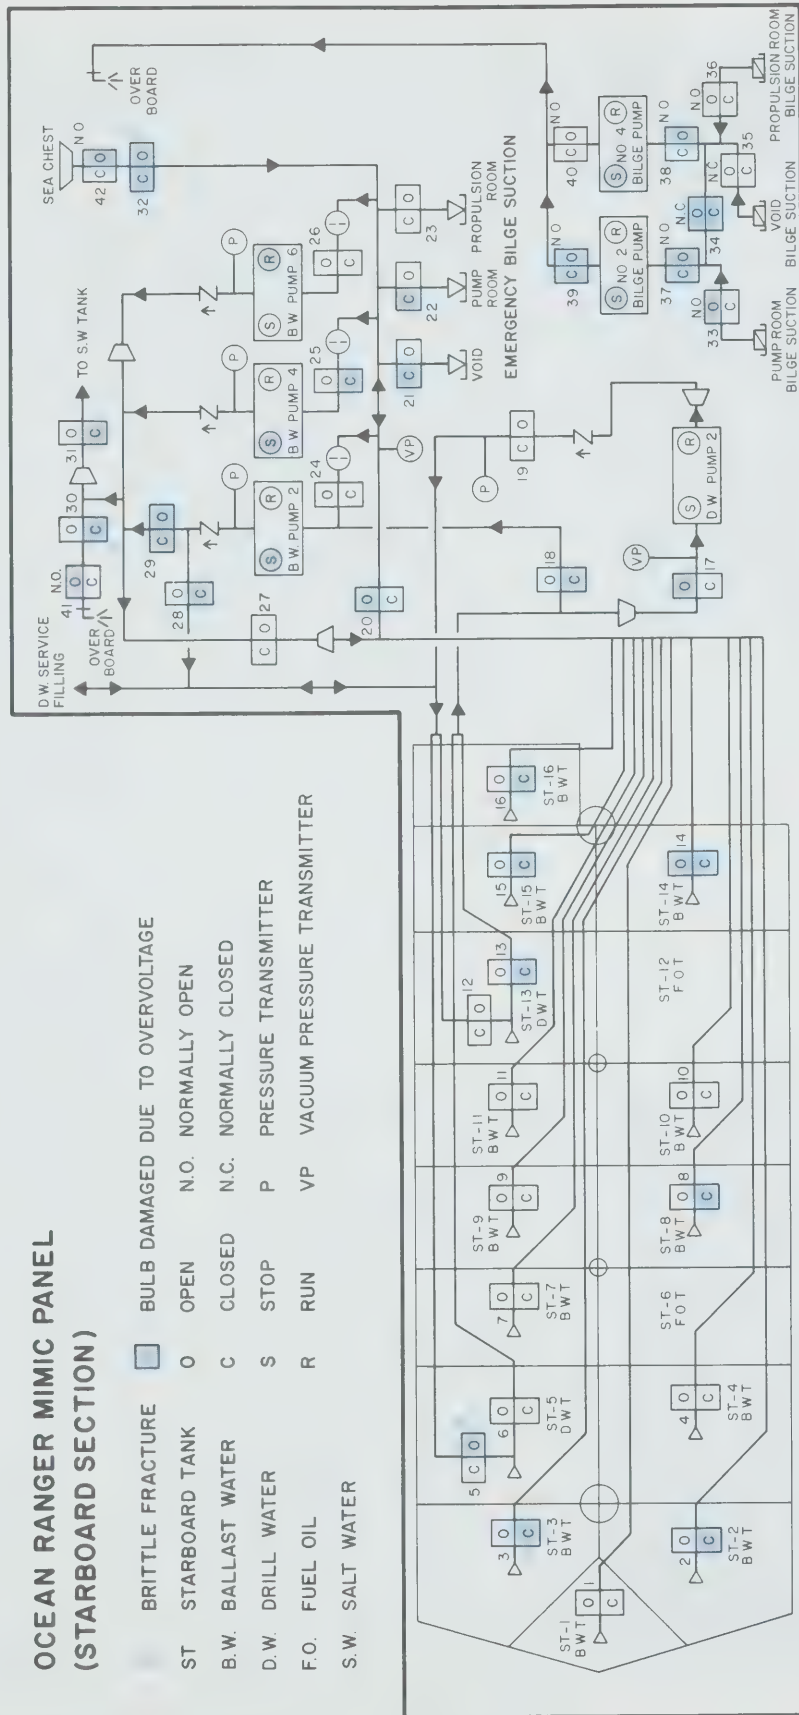
FIGURE 2 Starboard Mimic Panel.

BULB DAMAGED DUE TO OVERVOLTAGE
 ST STARBOARD TANK O OPEN N.O. NORMALLY OPEN
 B.W. BALLAST WATER C CLOSED N.C. NORMALLY CLOSED
 D.W. DRILL WATER S STOP P PRESSURE TRANSMITTER
 F.O. FUEL OIL R RUN VP VACUUM PRESSURE TRANSMITTER
 S.W. SALT WATER

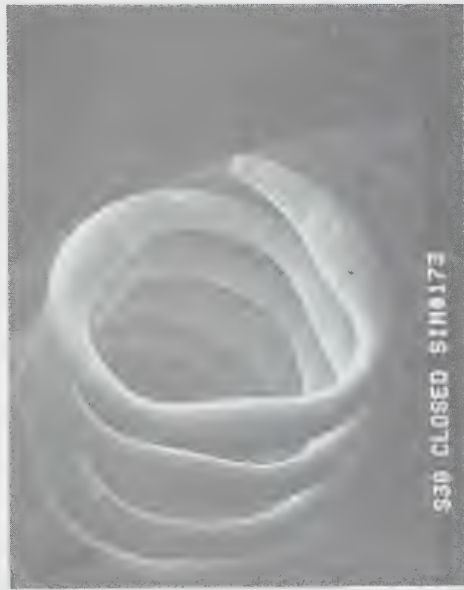
PHOTO 9 Filament from simulation panel flooded with water.

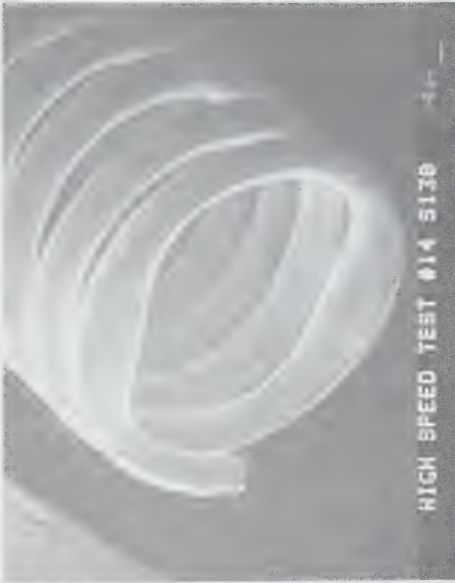
PHOTO 10 Filament experiencing 70 volts AC in the laboratory.

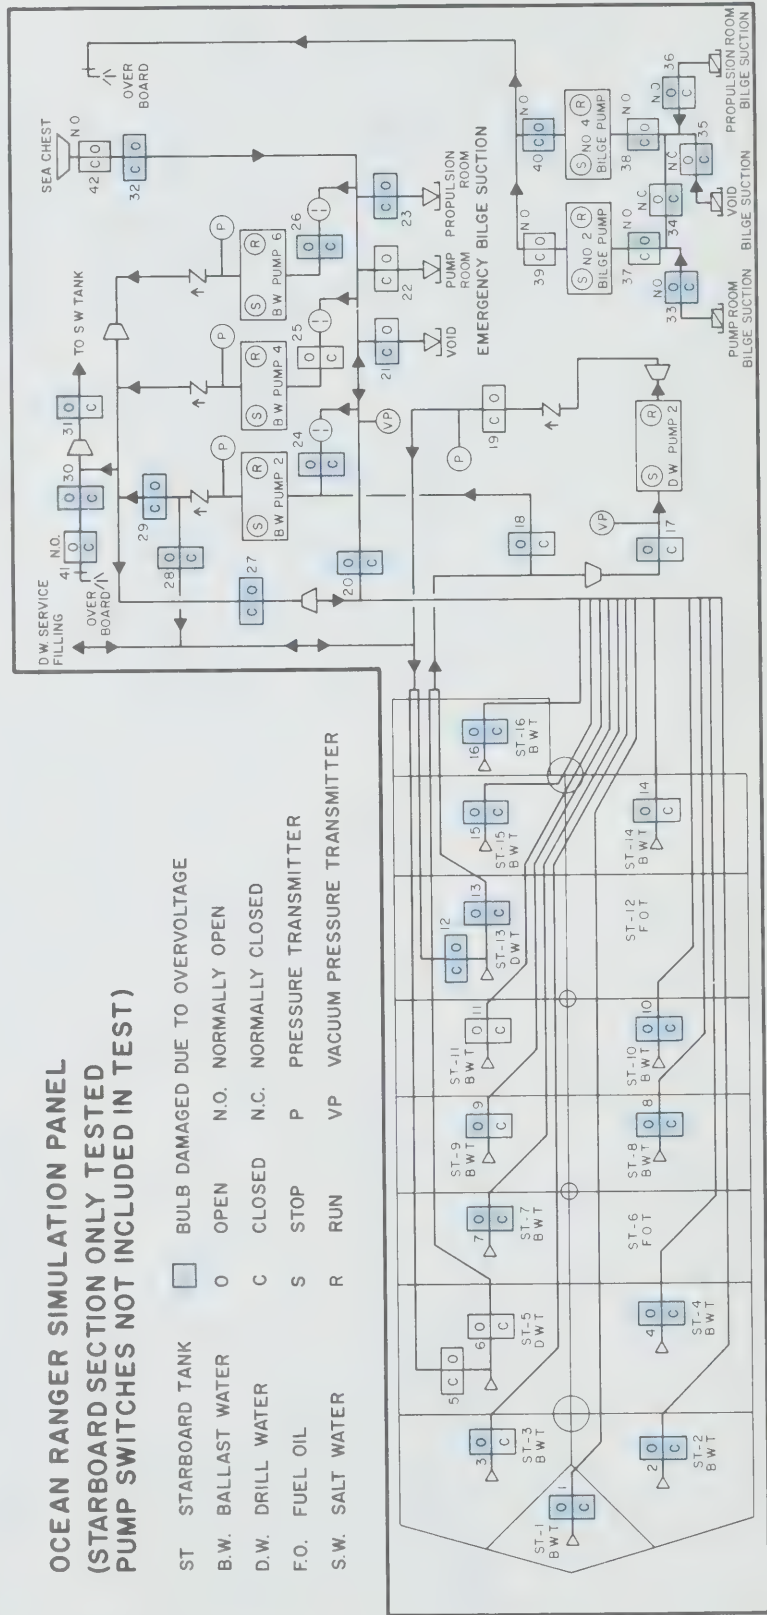
FIGURE 3 Starboard Mimic Panel (Simulator).

ST	STARBOARD TANK	<input type="checkbox"/>	BULB DAMAGED DUE TO OVERVOLTAGE
B.W.	BALLAST WATER	O	OPEN
D.W.	DRILL WATER	C	CLOSED
F.O.	FUEL OIL	S	STOP
S.W.	SALT WATER	R	RUN
		P	PRESSURE TRANSMITTER
		VP	VACUUM PRESSURE TRANSMITTER

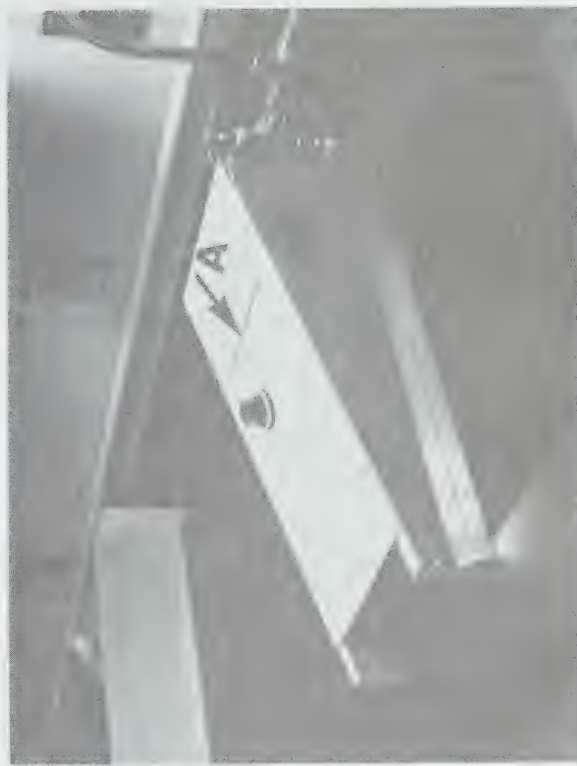
PHOTO 4 The test fixture for water ingestion test, showing the slot at A.

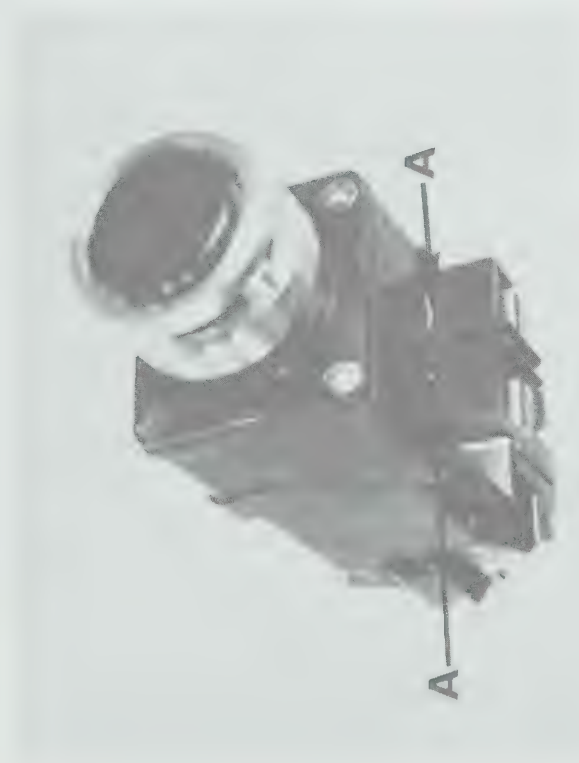
3.1 It has been demonstrated that sea water could easily have (and most likely did) run along the underside of the ballast control panel and entered the pump switch bodies near the light terminals.

PHOTO 1 Pump switch green or red, showing the cavity on the side of the body where water can enter at A.

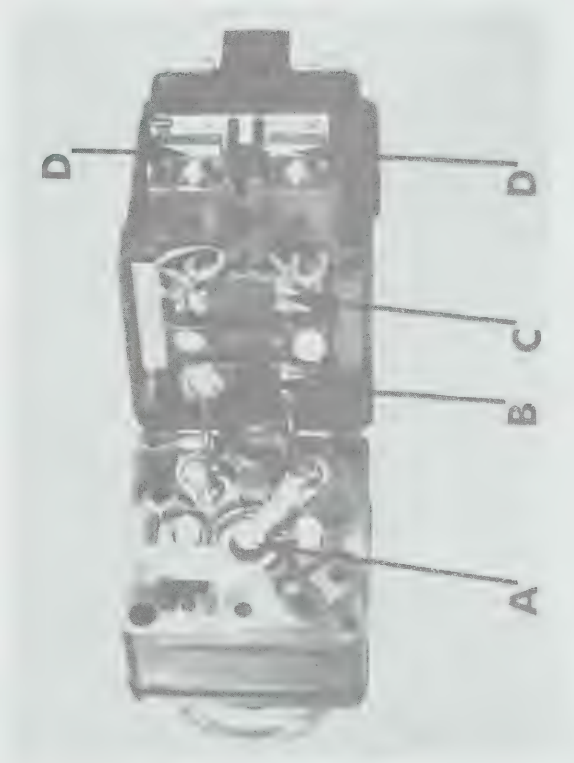
3.2 It has also been demonstrated that the pump switch indicator lights can burn out after the entry of sea water, providing the light bulb filament was substantially damaged by age.

PHOTO 3 The same switch split at the transformer and button light interface. A is the bottom of the light bulb socket, B secondary winding, C is the primary winding and D is the external transformer connections.

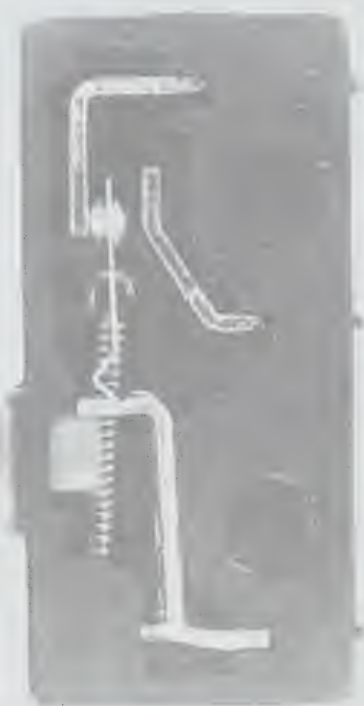
PHOTO 2 A typical microswitch with the side of its housing removed, showing its mechanism.

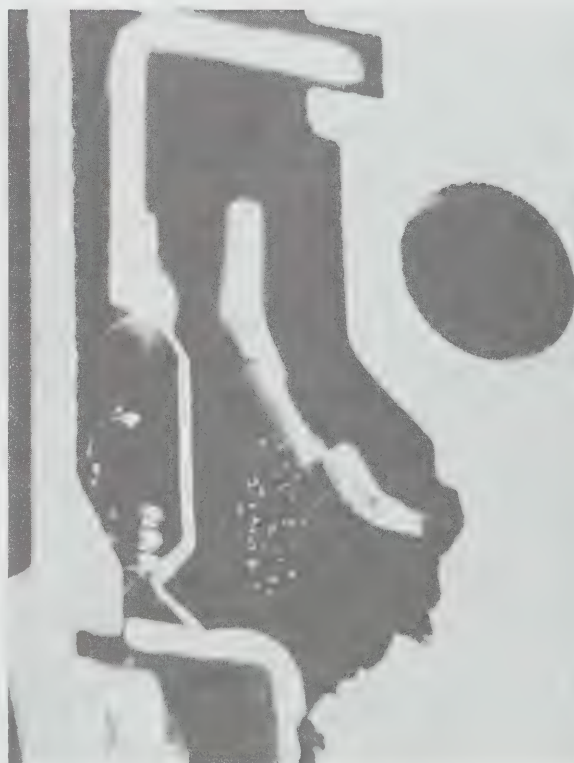
PHOTO 3 Detail of the microswitch mechanism showing the white specks deposited on the gold plated contact bar.

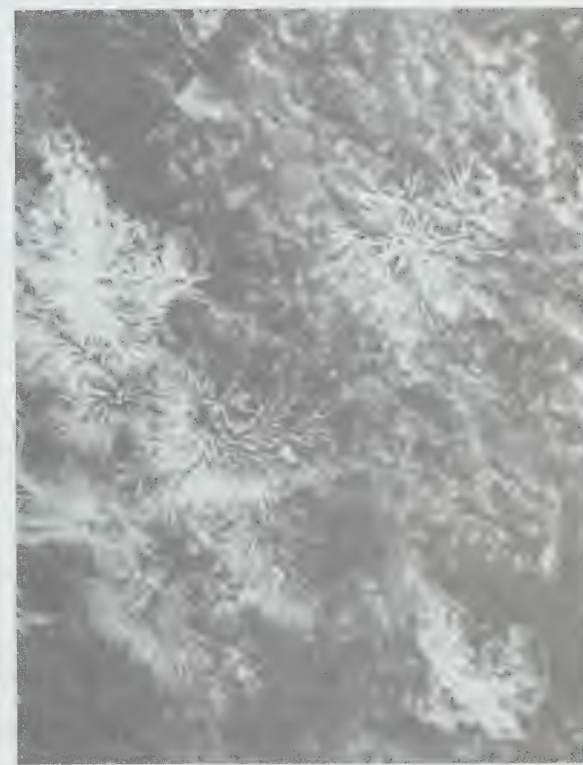
PHOTO 7 Micrograph showing the various crystalline deposits on a switch component

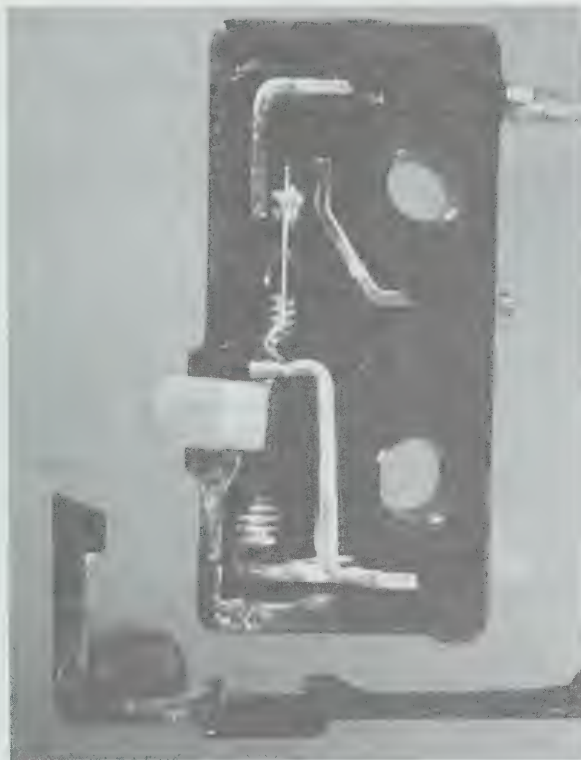
PHOTO 6 Microswitch showing evidence of sea water having entered through a separation in the casing halves.

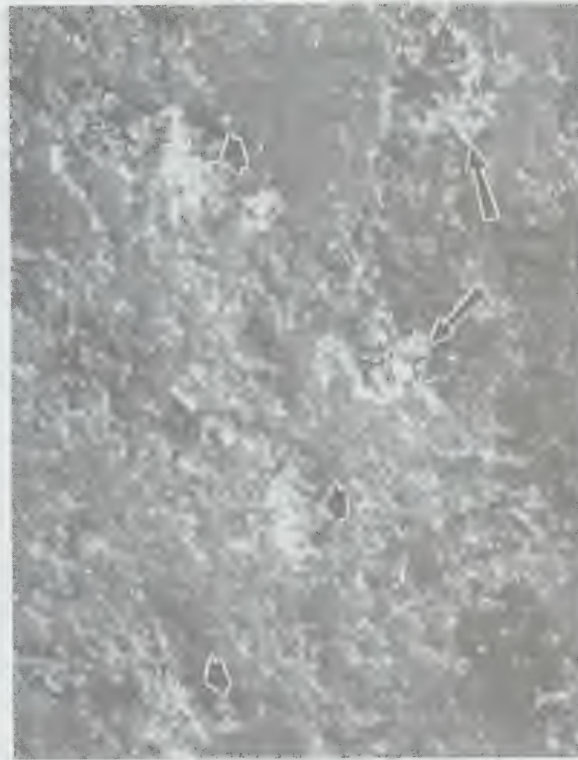
PHOTO 8 Micrograph details of some typical spikey crystalline deposits.

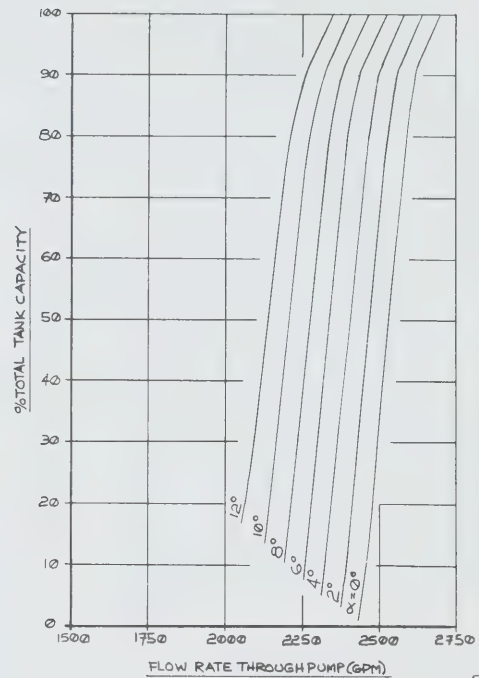
FIG. 9

The constant-speed pump motors cause cavitation at the impellers when pumping with 1 pump from tanks 2 or 3 separately for all angles of forward trim and at zero trim even when the tanks are nearly full. When drawing from tanks 2 and 3 together using 1 pump, cavitation occurs at all forward trims in excess of about 5° when the tanks are full. At zero trim cavitation will occur at all tank levels below approx. 10 ft. or about 38% of their total capacity. It follows that the pumping of the number 1 tanks will also cause cavitation at all levels below approximately 26.5 ft. or about 65% of their total capacity. The exact relationship between cavitation and pumping rate is not known, though in general the pumping rate will decrease in proportion to the degree of cavitation. Cavitation will increase with increasing suction head levels.

DETERMINATION OF CAVITATION POINT

PUMPING FROM NOS. 263 TANKS

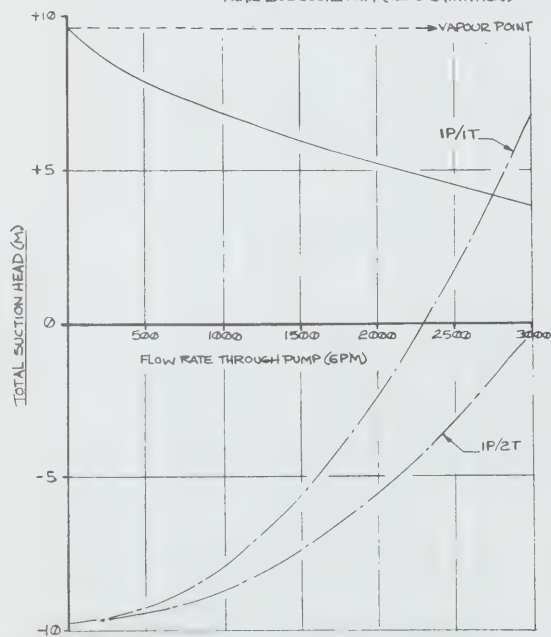
FIG. 10

ALLOWABLE FLOW RATES FOR ZERO CAVITATION

PUMPING FROM NOS. 263 TANKS

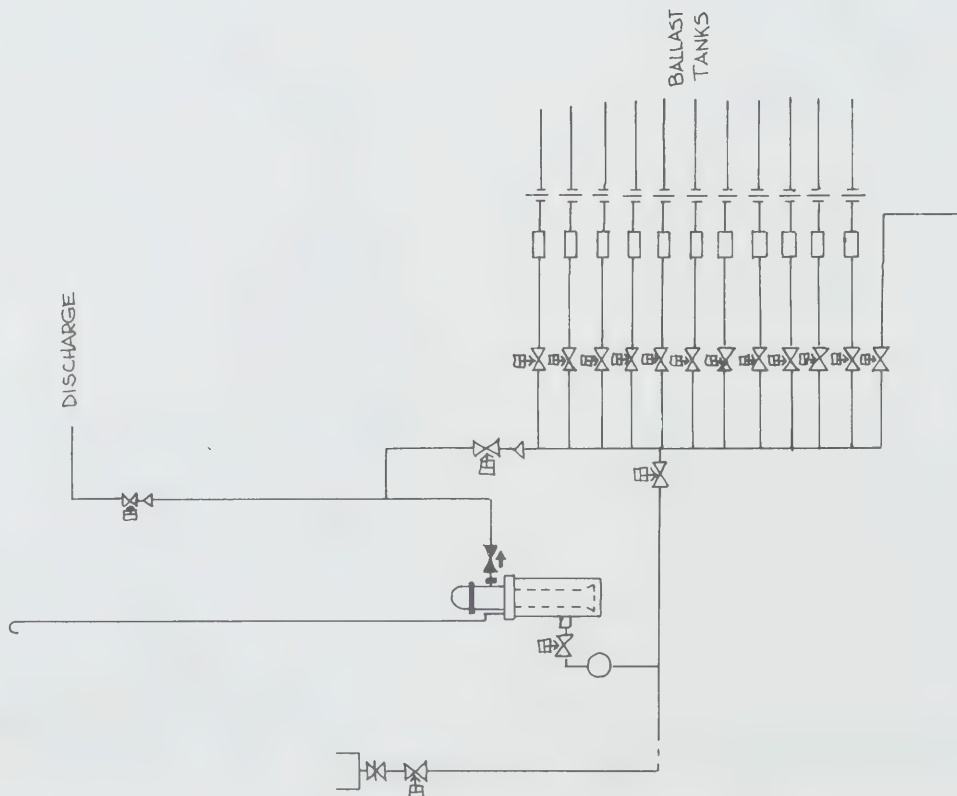
FIGURE 14

If the forward tanks had been connected by one manifold and the after tanks by another, it would have been possible to pump ballast between forward and after tanks. Figure 14 shows the arrangement as fitted and Figure 15 a suggested alternative, perhaps not optimum, which would be more flexible and permit transfer rather than discharge and replacement. This lack of internal transfer capability must be considered to be a defect in the ballast piping system.

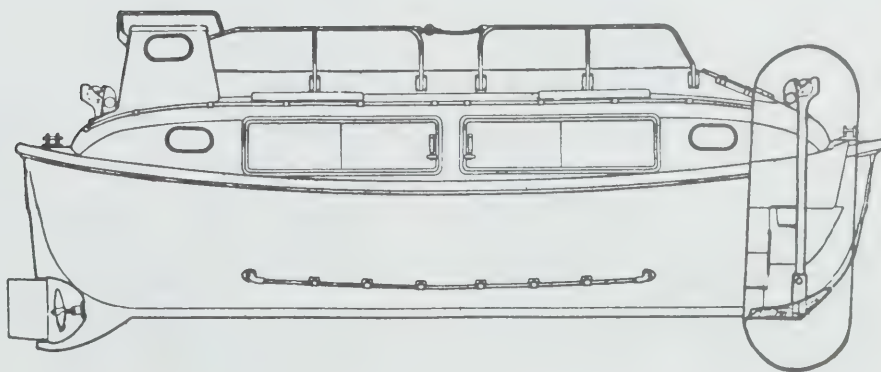
In the process of recovering the boat with cables, the boat suffered additional damage. This is apparently when the cover was crushed and the hull damaged in a number of places (reference 11d). In addition to the damage caused by the release gear, there were two other areas of damage that apparently did not occur during recovery. These are two "L" shaped inward fractures on either side of the hull several feet aft of the bow. These fractures match the position of the davit chocks on the launching platform and indicate that the launching sequence for this boat may not have begun, or had just begun when it was separated from the launching platform. The boat and its release gear arrangement are shown in Figure 1.

FIGURE 1 Harding 26 ft. totally enclosed lifeboat. Internal view at forward end shows release gear arrangement. The hook is attached to a support bar which is in turn attached to the keel shoe by a pin joint. The keel shoe is "glassed in" at the keel and is the means of transferring the load of the boat to the release gear. The support bar is held vertically by a flange bolted to the fiberglass at the point where the support bar penetrates the cover.

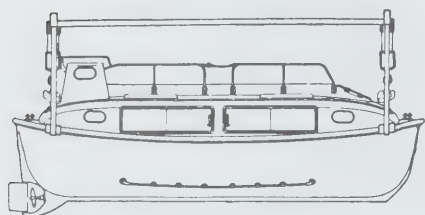
FIGURE 2A Harding lifeboat #1 shown in normal stowage position in davit.

Figures 2a through 2d depict a series of events which could account for the damage sustained by this boat. Note that there were no surviving witnesses to the release of this boat or any of the other boats, and consequently no testimony to support this scenario. It is deduced from the damage found during the post-casualty inspection of the boat, and in the opinion of the author represents the most probable series of events. The following is a description of the events depicted in Figures 2a through 2d:

a. Boat #1 was at the port bow, the area of the *Ocean Ranger* which is believed to have been the first area of the main deck to enter the water. Seas were heavy at the time, so as the launching platform with the boat approached the water, it would have been struck by a series of waves. The waves were such that the boat would have been subject to severe forces as is evident by the distortion and damage in the aft release hook supporting structure and surrounding FRP laminate. The waves would have lifted and dropped the boat repeatedly, and when the boat was supported by a wave the load would be off the release hook and it could be easily moved to the open position by overcoming the force of the counterweight on the hook. This apparently happened to the aft hook while the boat was being battered by the waves resulting in release of the aft hook. The damage to the rear helmsman's tower and hatch could have occurred at this point since the aft release gear is adjacent to this area.

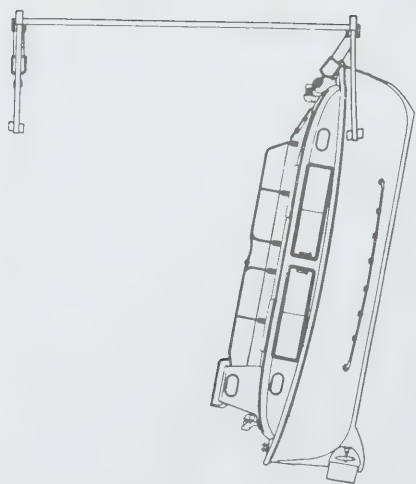
b. Supported only by the forward hook, the davit chocks on the launching platform lost contact with the gunwale and dug into the hull below and behind their normal position, as the boat was wedged between the chocks on either side. This caused the "L" shaped fractures discussed above. Had the launching sequence been started, the davit chocks would not have contacted the hull in this manner.

FIGURE 2B Aft release hook has been opened, allowing aft end of boat to fall. Davit chocks at forward end normally in contact with gunwale dig into hull, leaving "L" shaped inward fractures on both sides of the hull.
